Bridge Deficiency Evaluation and Repair Recommendations

Bridge Assessments
Charlemont, MA
March 31, 2016

Town of Charlemont

Gill Engineering Associates, Inc.
63 Kendrick Street
Needham, MA 02494

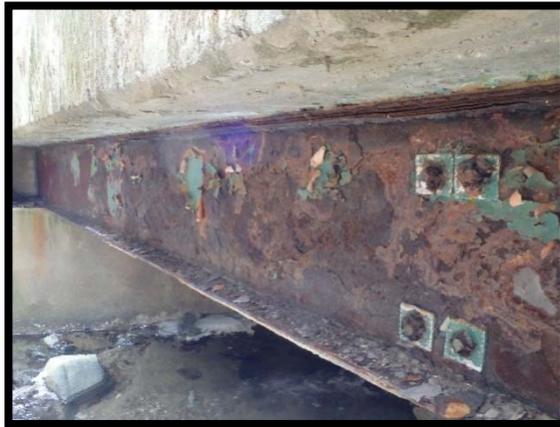
Severe Deficiencies include the deck, the steel beams, the paint system, and the traffic safety features. The bridge is closed due to severe deterioration of the steel beams. The bridge deck exhibits severe spalling (broken concrete) at numerous locations with a full depth hole at one location. The deck's reinforcing steel has heavy corrosion with section losses of up to 50%. The steel beams have severe corrosion with extensive holes through the bottom flanges and webs at numerous beam ends. The bottom flanges of the exterior beams have severe section losses running full length. The interior beams also have severe bottom flange corrosion extended up to 7' feet from the beam ends. The paint corrosion protection system has failed leaving most of the steel exposed and corroding. The bridge approach railing, transitions and terminations are in poor condition and do not comply with current standards.

Bridge C-05-028: Severe Corrosion of Steel

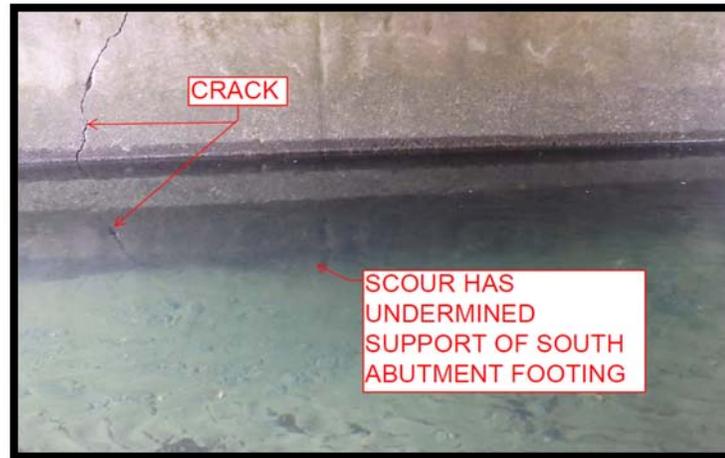
Severe Deficiencies include severe corrosion of the steel beams, scour of the waterway channel and south abutment footing, cracking of the south abutment breastwall and through the footing due to undermining, severe corrosion of the steel bearing plates, the paint system is failing, and the bridge and approach railing system is missing the timber rails and some of concrete posts are either broken or tipped.

Bridge C-05-030: South Abutment Footing Scour

Superstructure Replacement and Replacement of South Abutment: The bridge's superstructure (steel beams and deck) is in serious condition as a result of severe corrosion of the steel beams and deterioration of the concrete deck. Extensive scour of the south abutment footing has occurred resulting in undermining of the footing and cracking of the abutment breastwall and footing above the undermining. The main flow of the channel is directed along the south abutment. The extent of these deficiencies has rendered the existing superstructure and south abutment unsuitable for rehabilitation. The existing north abutment is in satisfactory condition and is considered suitable for reuse based upon its condition. Recommendation: Replace the existing superstructure with 4 steel beams and an arched concrete deck. The proposed railing system is metal thrie beam guardrail which will be carried through the approaches at all four corners and terminated. Replace the south abutment roughly 10' south of the existing abutment and place riprap scour protection. Analysis of the existing north abutment will be required to verify its stability for the proposed loads from the new superstructure.

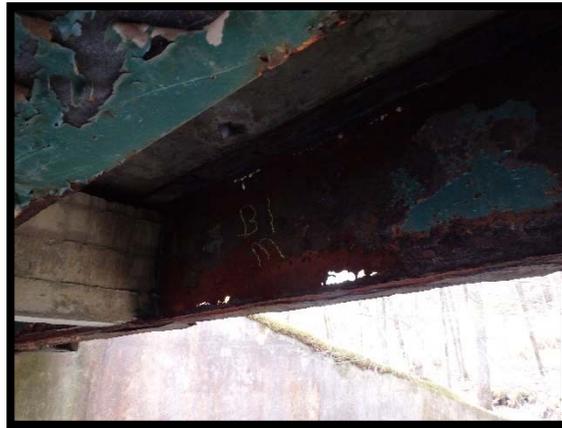
Bridge C-05-030: Severe Corrosion of Steel

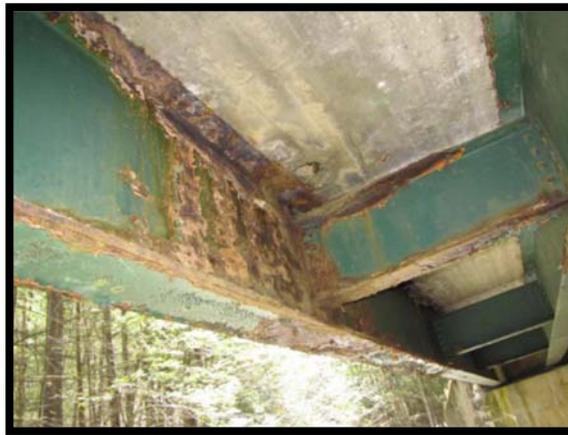
Severe Deficiencies include the paint system failure below the deck drains and the remainder of the paint system is in the process of failing. The exterior beams have extensive corrosion in the vicinity of the deck drains. The posted weight limit is governed by the capacity of the interior steel beams 2 and 5.

Bridge C-05-047: Severe Corrosion Beam 6

Steel Repairs: The bridge's exterior steel beams have extensive corrosion and loss of steel section due to deck leakage and drainage from the scuppers directly discharging roadway water onto the steel. Recommendation: Strengthen the existing bottom flanges of the exterior beams. Implementation of this recommendation would allow for the removal of the existing temporary concrete barrier that is currently in place to limit loading of the exterior beams. The bridge would still require a posted weight limit of approximately 15, 17, and 25 tons for the 2 axle, 3 axle, and 5 axle trucks respectively. It would also be necessary to strengthen the interior beams (Beams 2 through 5) in order to be able to remove the posted weight limit as the bridge was designed to support 15 ton 2 axle truck loads. It is noted that strengthening the bottom flanges by adding bottom flange cover plates would be difficult as the extent of the corrosion would make effective attachment of the new cover plates difficult. For this reason, strengthening the beams using a system of anchored tension rods is preferred. The following preliminary cost estimate assumes that only the exterior beams will be repaired.

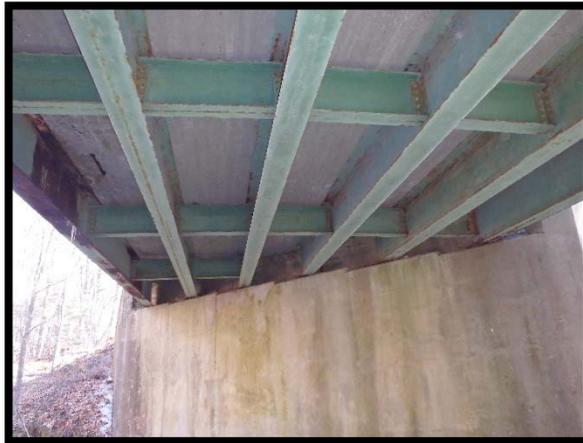
Bridge C-05-034: Corrosion of Beam 1

Minor Deficiencies include the deck drainage system, the steel beams, the paint system, and the wingwalls. The deck drains allow direct discharge of water onto the exterior steel beams. The exterior steel beams have extensive corrosion due to water exposure. The paint system has failed below the deck drains. Heavy abutment seat and breast wall deterioration has occurred at the junction with the southwest wingwall, resulting in undermining of the bearing at Beam 6. Moderate to heavy concrete deterioration is also noted at all four of the wingwalls.

Steel Repairs: The bridge's exterior steel beams have extensive corrosion and loss of steel section due to deck leakage and drainage from the scuppers directly discharging roadway water onto the steel. Recommendation: Strengthen the existing bottom flanges of the exterior beams. Implementation of this recommendation would allow for the removal of the existing temporary concrete barrier that is currently in place to limit loading of the exterior beams. If implemented, these repairs would allow the bridge to not require a posted weight limit as the bridge was designed to support 20 ton 2 axle truck loads. It is noted that strengthening the bottom flanges by adding bottom flange cover plates would be difficult as the extent of the corrosion would make effective attachment of the new cover plates difficult. For this reason, strengthening the beams using a system of anchored tension rods is preferred.

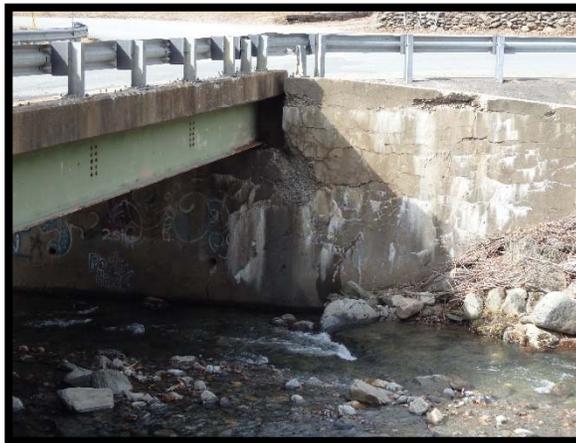
Minor Deficiencies include the paint system, and the wingwalls. The paint system is failing along the bottom flange edges and where previous leakage of water through the now repaired deck in bays 2 through 4 caused steel corrosion. The abutment seats, breastwalls, and adjacent wingwalls have heavy deterioration at all four corners. Roadway water drains onto the bridge seats at each corner of the bridge leading to this deterioration. Moderate to heavy concrete deterioration is also noted at all four of the wingwalls.

Bridge C-05-002: Wingwall Deterioration

Repair Deteriorated Substructure Concrete: Moderate to heavy abutment and wingwall deterioration has occurred, particularly where the exterior beams are supported at each abutment where they meet the wingwalls. Recommendation: Remove and replace deteriorated substructure concrete. Provide temporary shoring of each exterior beam end at each abutment in order to perform concrete repairs at the bridge seat where the bearings may become partially undermined.

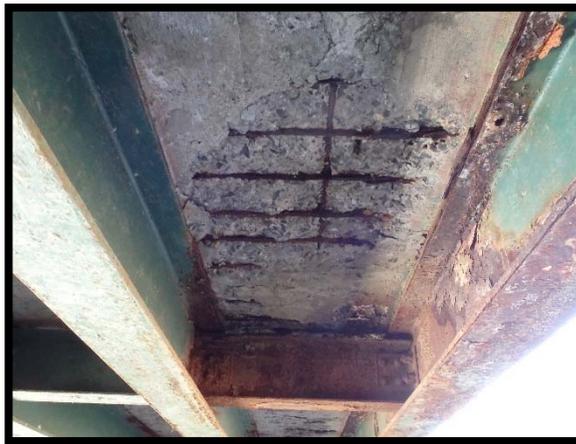
Severe Deficiencies include the bridge deck and railing system. The deck has extensive spalling (cracked concrete) with exposed severely corroded reinforcing steel. The deck has been patched and the patches are delaminating from the surrounding concrete. The bridge railing is missing many sections of timber rails and the remaining timber rails are rotted and split.

Bridge C-05-027: Deck and Paint System Deterioration

Replace Bridge Deck: The existing bridge deck is in poor condition, with heavy spalling (cracked concrete), exposed reinforcing steel that is severely corroded at various locations, and concrete repair patches that have de-bonded from the surrounding concrete. The bridge railing is also severely deficient. Recommendation: Replace the existing reinforced concrete bridge deck and railing system. The proposed deck will conform to MassDOT standards and the proposed railing system is metal thrie beam guardrail which will be carried through the approaches at all four corners and terminated.

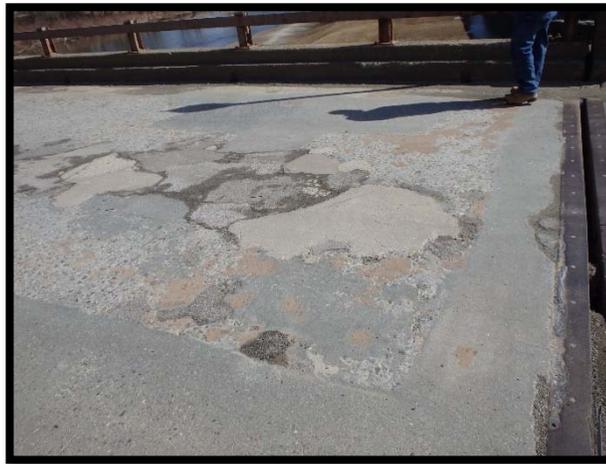
Severe Deficiencies include the bridge deck wearing surface and the bridge deck joints. At some point in the past, the bridge deck was given a thin epoxy wearing surface overlay that had fine aggregate embedded in it. The vast majority of this wearing surface has worn away leaving a bare deck. The bridge deck has areas of exposed reinforcing steel where potholes up to 3' in diameter and 2" deep have formed. Some potholes have been patched and cracking of the patches was observed. The underside of the deck where it overhangs the exterior beams has extensive spalling (cracked concrete) with exposed corroded reinforcing steel primarily where drainage scuppers are located. The deck joints are located at each abutment. The deck joint seals have torn and have pulled free from their supports, particularly at the south abutment. This has allowed a significant amount of sand and debris to accumulate on the bridge seat and steel beam ends.

Bridge C-05-010: Deck Deterioration and Failed Joint Seal

Perform Bridge Deck Rehabilitation: The bridge deck has areas of exposed reinforcing steel where potholes up to 3' in diameter and 2" deep have formed. Some potholes have been patched and cracking of the patches was observed. The underside of the deck where it overhangs the exterior beams has extensive spalling (cracked concrete) with exposed corroded reinforcing steel primarily where drainage scuppers are located. Recommendation: Replace the reinforced concrete deck overhang and first interior deck bay on each side of the bridge. Perform hydro-excavation of the remainder of the deck to remove deteriorated concrete, followed by placement of rapid setting durable deck repair concrete that will also function as the riding surface. The proposed bridge cross section would consist of two 12' wide travel lanes and 18" wide safety curbs and three beam bridge railing on each side. Replace deck joints at each end of the bridge. It is proposed that this work be performed in 2 stages while maintaining a single reversible lane during construction using temporary traffic signals.

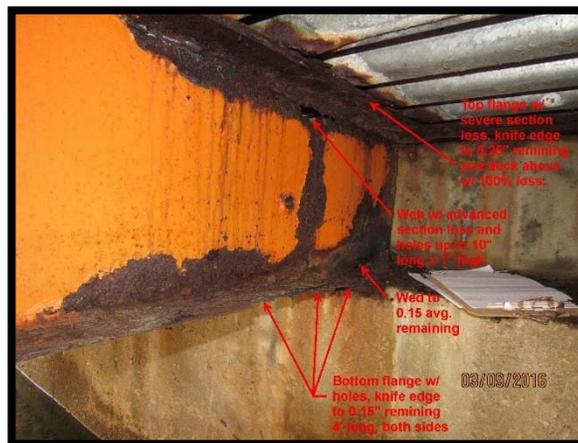
Severe Deficiencies include severe corrosion of the corrugated metal deck above both ends of Beam 5 and the severe corrosion of the ends of Beam 5 directly beneath. The top flange of Beam 5 is mostly corroded away and the web has advanced section loss with holes up to 10" long and 1" high. The bottom flange also has little remaining area for a length of about 4'. The corrosion protection system has failed leaving large areas of the steel with little or no remaining paint.

Bridge C-05-054: Beam 5 End Corrosion and Corrugated Deck Deterioration

Superstructure Replacement: The bridge's superstructure has areas of severe corrosion of the steel beams and corrugated metal deck. The corrugated metal decking is prone to corrosion that would require it to be replaced at regular intervals. The existing substructure is in satisfactory condition and is considered suitable for reuse based upon its condition. Recommendation: Replace the existing superstructure with 5 steel beams and an arched concrete deck. The proposed railing system is metal thrie beam guardrail which will be carried through the approaches at all four corners and terminated. Analysis of the existing substructure will be required to verify its stability for the proposed superstructure replacement.

It is possible that the Legate Hill Brook bridge could be closed as a result of the first inspection performed by MassDOT in March 2016, or as a result of load rating the bridge. In the interim, it is recommended that heavy timber blocking be installed on top of the bridge seats on each side of Beam 5. These temporary repairs should be designed to provide an alternate load path in case the ends of Beam 5 were to buckle or the corrugated metal decking were to fail where it bears upon the top flange of Beam 5 near the abutments.
